| <b>FISKVINNSLUSKÓLINN Í HAFNARE</b> | | Verk nr. | | |
| Sérteikning af þaknidurfalli P1 | | TEIKNING NR. | | |
| Holrásalögn | | 5R-55 | | |

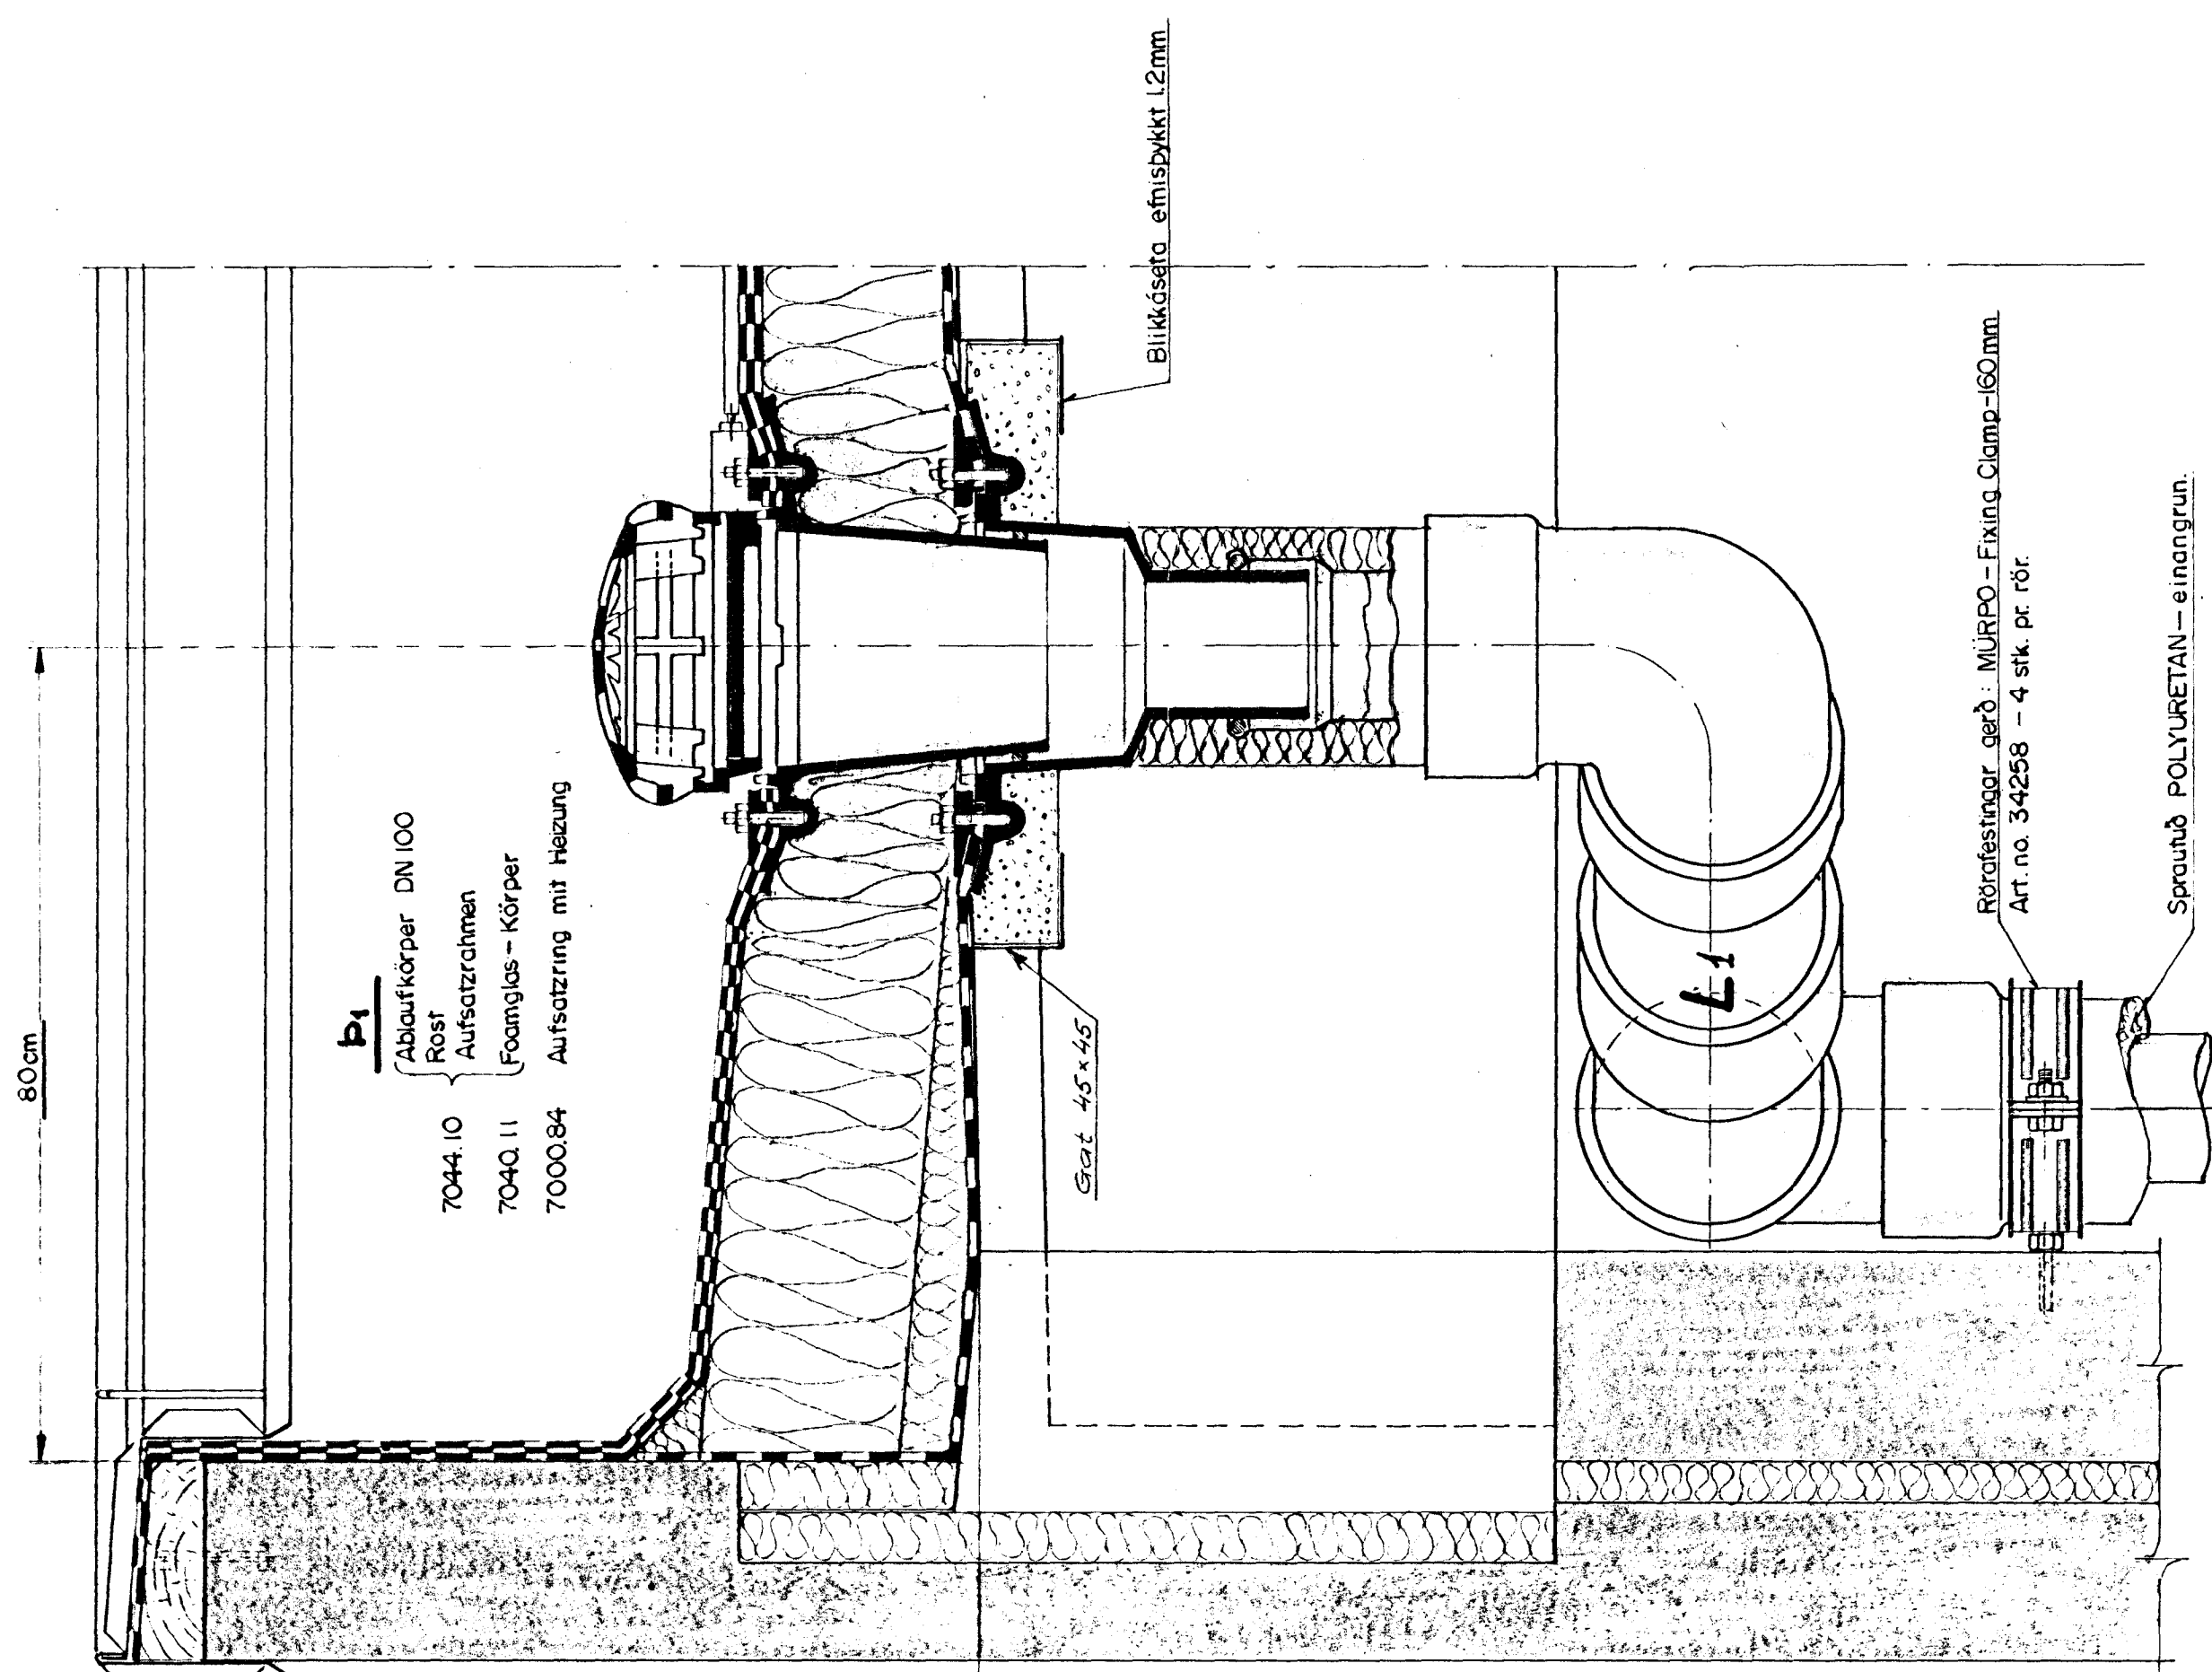
**SNID A-A**  
**P1**  
**INNBYGGT ÞAKNIDURFALL**  
 1:5

- Abstrakör DN 100
- 704Q.10 Rör
- 704Q.11 Foamsglas - Körper
- 7000.84 Aufsatzring mit Heizung
