Rúmmynd ofnalagnar 1:50

Rúmmynd neysluvatnslagnar 1:50

Breytingar			Suðurholt 14	
Nr.	Dags.	Nafn		
1.	25.05.99	BA	Tekniþjónusta Bjarna Arnasonar ehf.	Bjarni Arnason
			Smiðjuvegi 11 s: 564 2260 fax: 564 4681	Mkv. 1:50
			Rúmmynd ofnalagnar	Nr. 4L
			Rúmmynd neysluvatnslagnar	Dags. 25.03.'99
				kt.:290461-4489

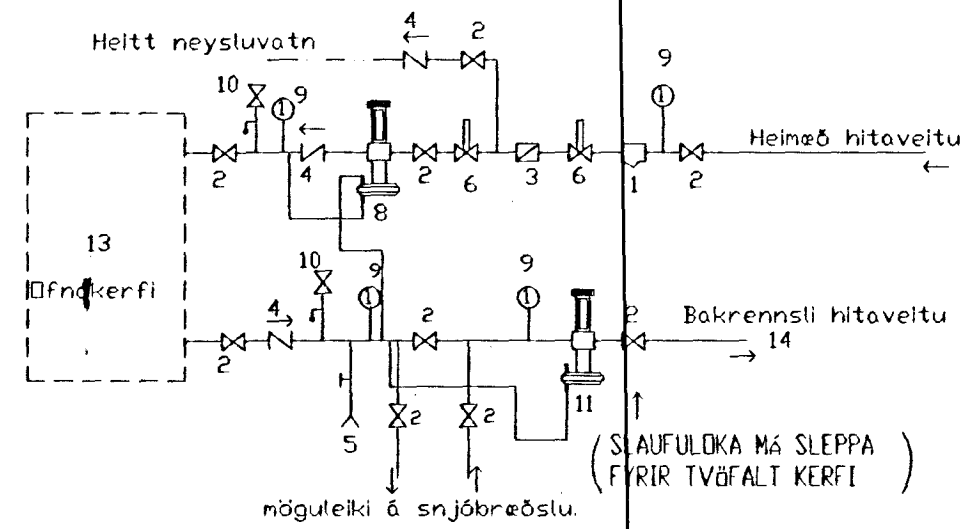
MÆLAGRIND HITAVEITU:  
Skematísk mynd

- 1 : Sía
- 2 : Renniloki
- 3 : Mælir
- 4 : Einstreymislöki
- 5 : Tening
- 6 : Sjálfvirkur rennsliserill
- 7 : Þrýstímælir
- 8 : Þrýstijafnari
- 9 : Hita og þrýstímælir
- 10 : Öryggislöki
- 11 : Mötþrýstilöki
- 12 : Heitt neysluvatn
- 13 : Öfnakerfi
- 14 : Affall hitaveitu
