| Breytingar | | | Suðurholt 16 | |
| | | | Tækniþjónusta Bjarna Arnasonar ehf.<br>Smíðjuvegi 11 s: 564 2260 fax: 564 4681 | |
| | | | Nr. 5L | |

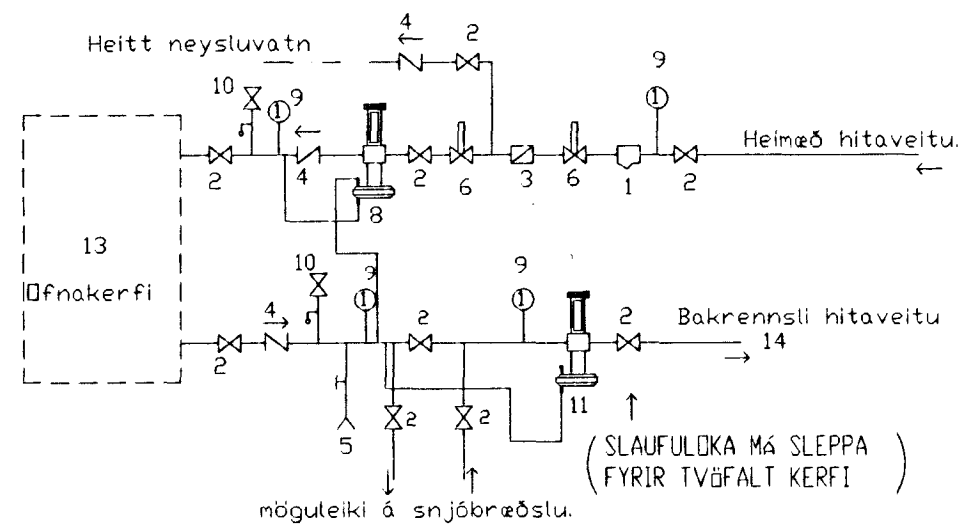
MÆLAGRIND HITAVEITU:  
Skematísk mynd

- 1 : Sía
- 2 : Renniloki
- 3 : Mælir
- 4 : Einstreynisloki
- 5 : Tæning
- 6 : Sjálvvirkur rennlishemill
- 7 : Þrýstímælir
- 8 : Þrýstijafnari
- 9 : Hita og Þrýstímælir
- 10 : Öryggisloki
- 11 : Mótþrýstiloki
- 12 : Heitt neysluvatn
- 13 : Öfnakerfi
- 14 : Affall hitaveitu
