ERECTION DETAILS				
REV	DATE	BY	DESC	BUILDER
				Varco-Pruden Exports
				CUSTOMER: Sindri
				LOCATION: Iceland
				PROJ. NAME: Sindri Workshop
				BLOG. NAME: workshop 1

JOB NO. HE9970314-01-0E-
DATE 08/16/99
DRAWN BY DHG
CHKD. BY
PG 03

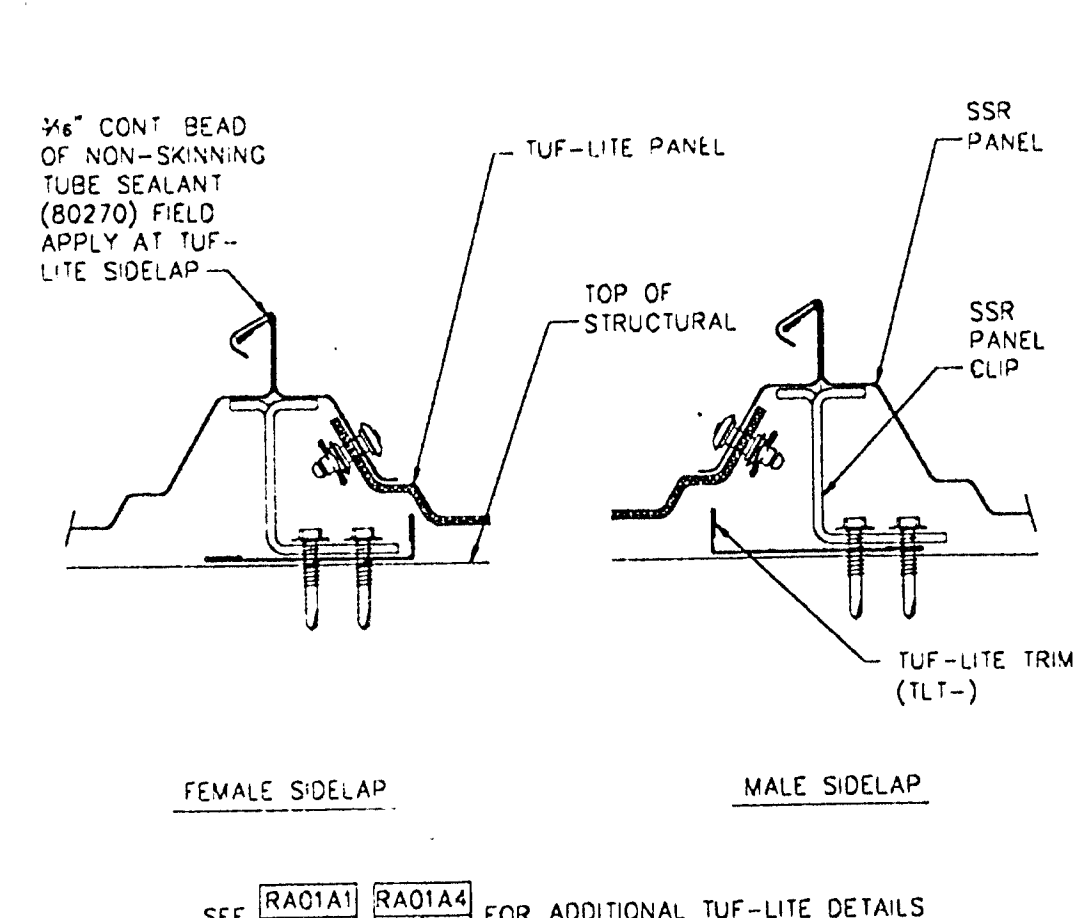
SSR TUF-LITE SIDELAPS RA01A2
NON-UL RATED
RA01A2V3 R 07/01/93

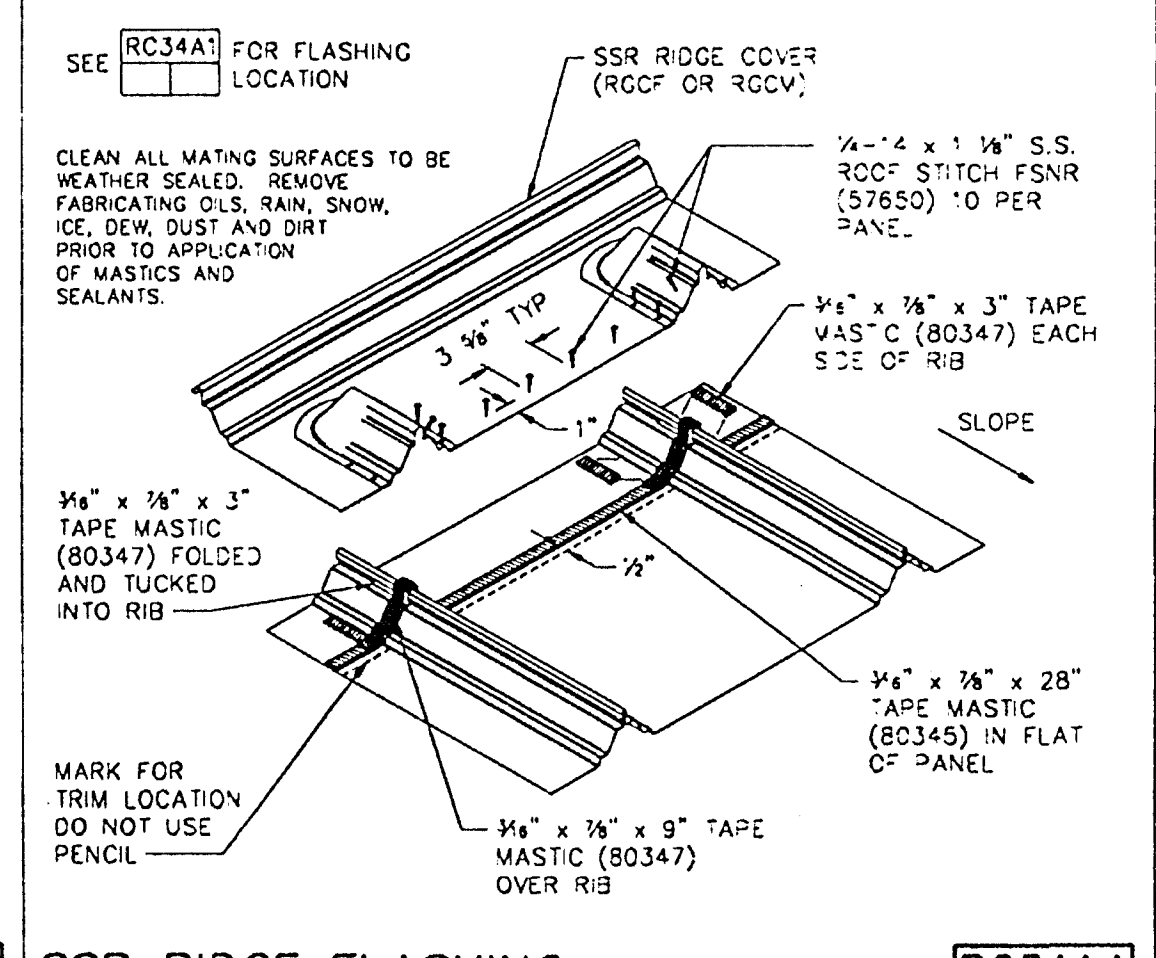
SSR RIDGE FLASHING RC34A4
FASTENER AND MASTIC PATTERN
RC34A4V1 03/01/90
