ERECTION DETAILS			
REV	DATE	BY	DESC
			BUILDER Varco-Pruden Exports
			CUSTOMER Sindri
			LOCATION Iceland
			PROJ. NAME Sindri Workshop
			BLOG. NAME workshop 1

JOB NO. ME9970314-02-021
DATE 08/16/99
DRAWN BY DHG
CHKD. BY
P 24/L

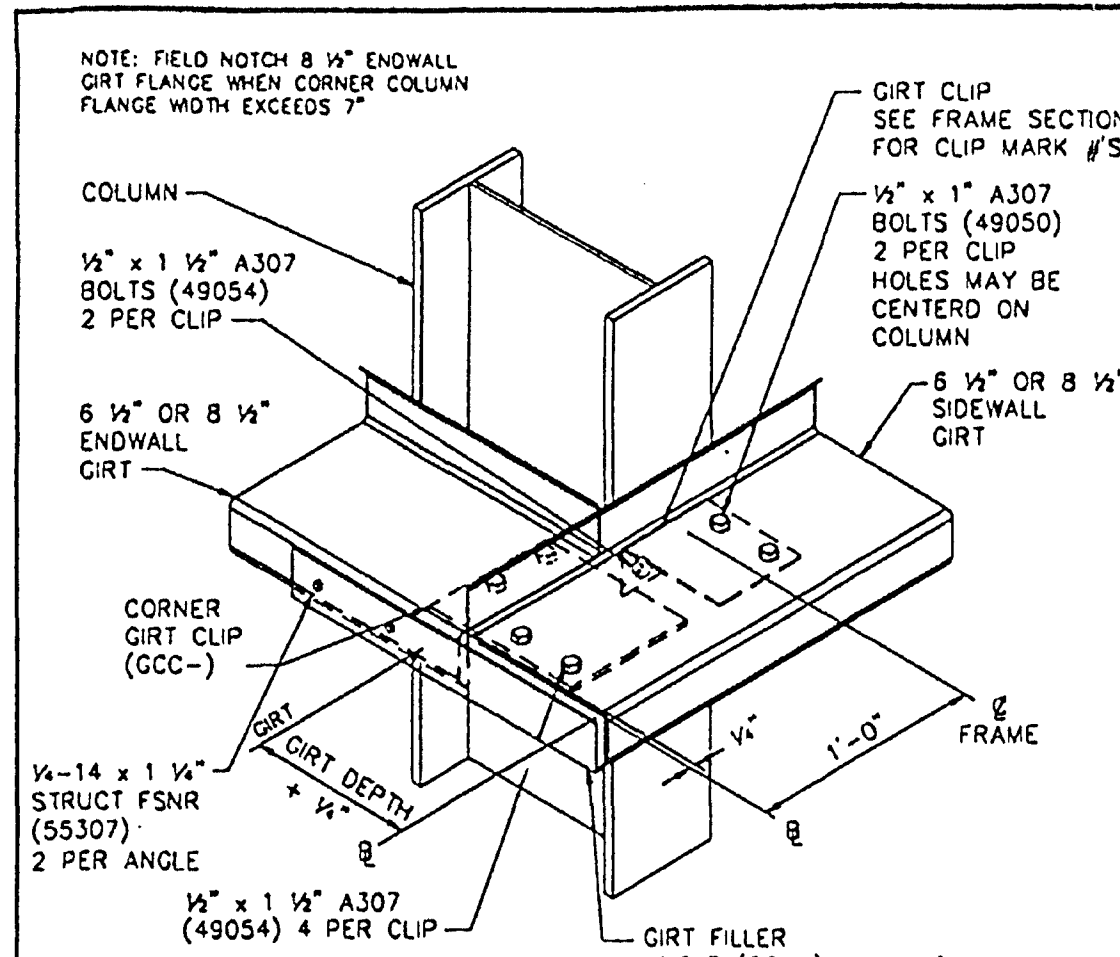
GIRT CONN. AT CORNER COLUMN WS12D2
 ANY OUTSET GIRT AT EW, ANY OUTSET GIRT AT SW
 WS12D2V4 R 07/10/93
