Smári Björnsson		
SÍMI: 868 1300 NETFANG: smari.bjornsson@gmail.com kt: 100275 5899		
HEITI VERKS:	Stuðlaskarð 12	
HEITI TEIKNINGAR:	verkeikningar deili	
MKV: 1:5	DAGS: 05.11.24	NR. TEIKN 1
UNDIRSKR.HÖNNUÐAR		ÚTGÁFA A

Smári Björnsson		
SÍMI: 868 1300 NETFANG: smari.bjornsson@gmail.com kt: 100275 5899		
HEITI VERKS:	Stuðlaskarð 12	
HEITI TEIKNINGAR:	verkeikningar deili	
MKV: 1:5	DAGS: 05.11.24	NR. TEIKN: 2
UNDIRSKR. HÖNNUÐAR:	ÚTGÁFA: A

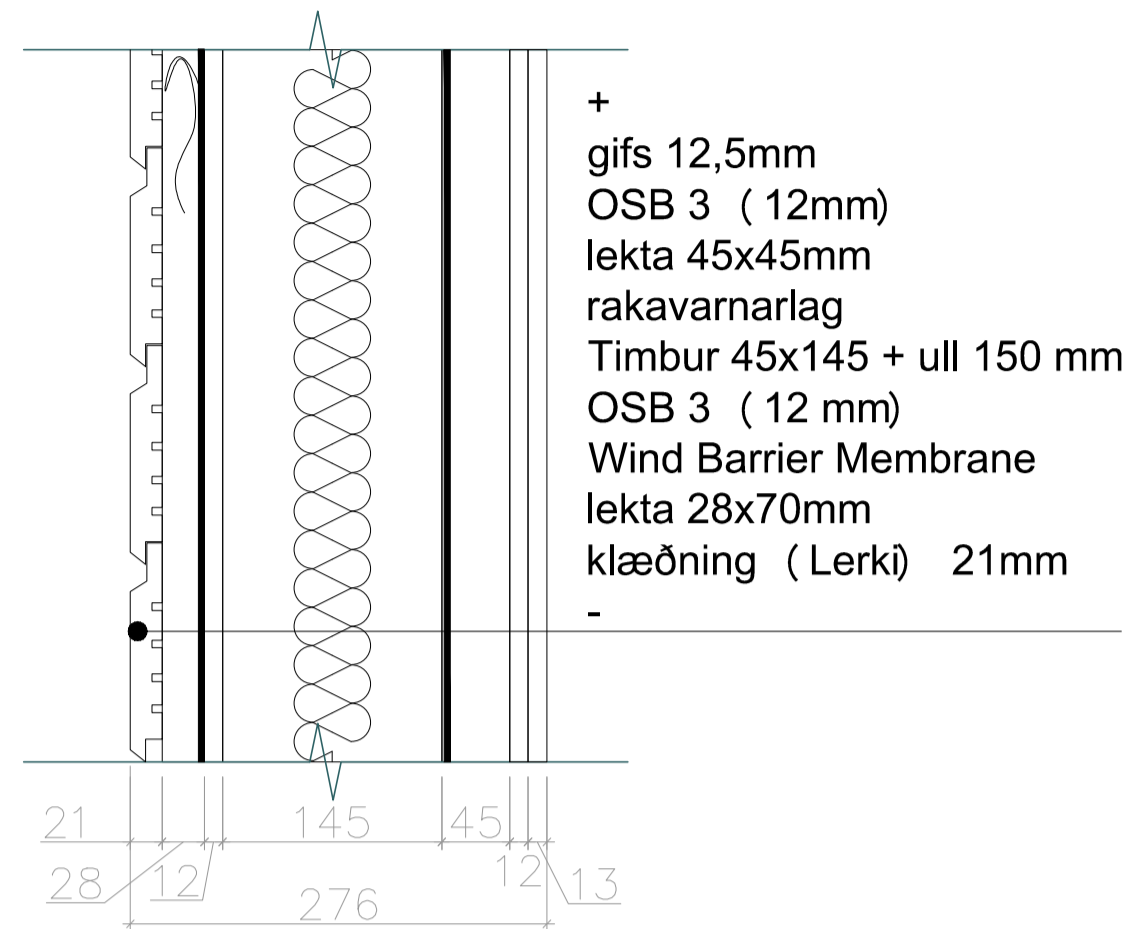
deili lóðrétt útveggur

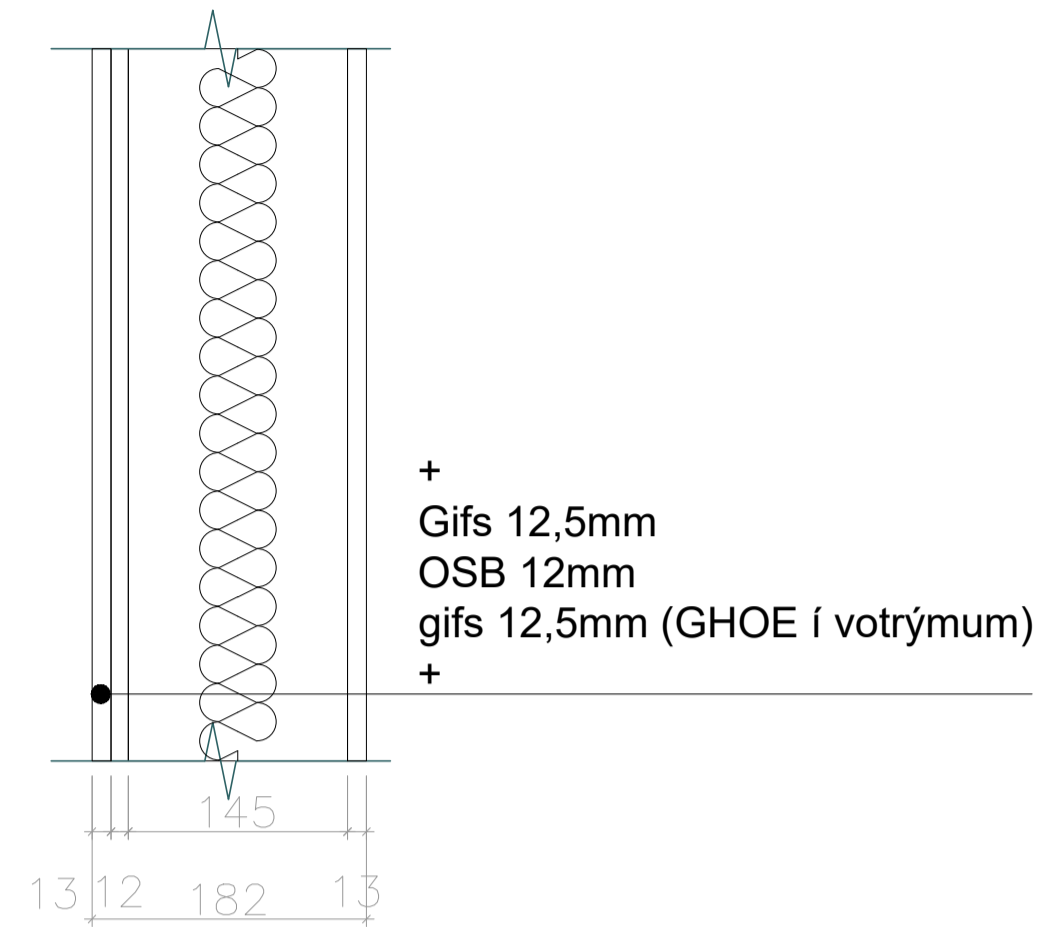
deili innveggur burðarveggur

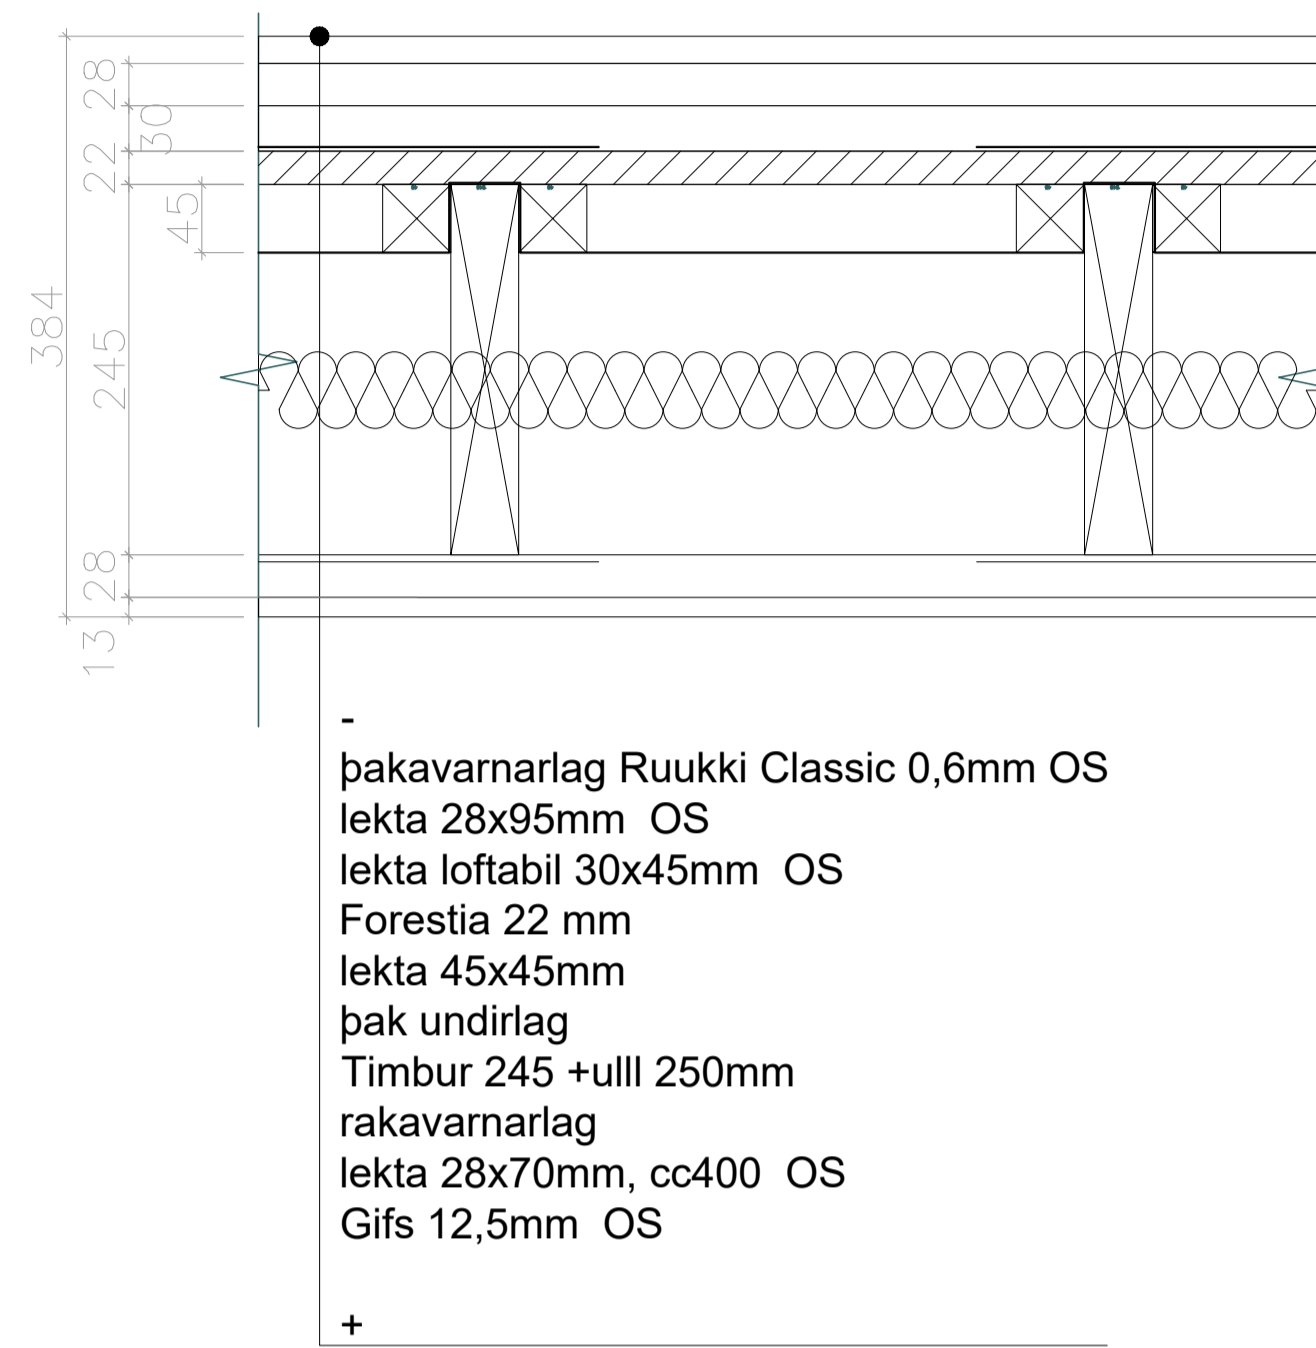
loft við geymslu loft

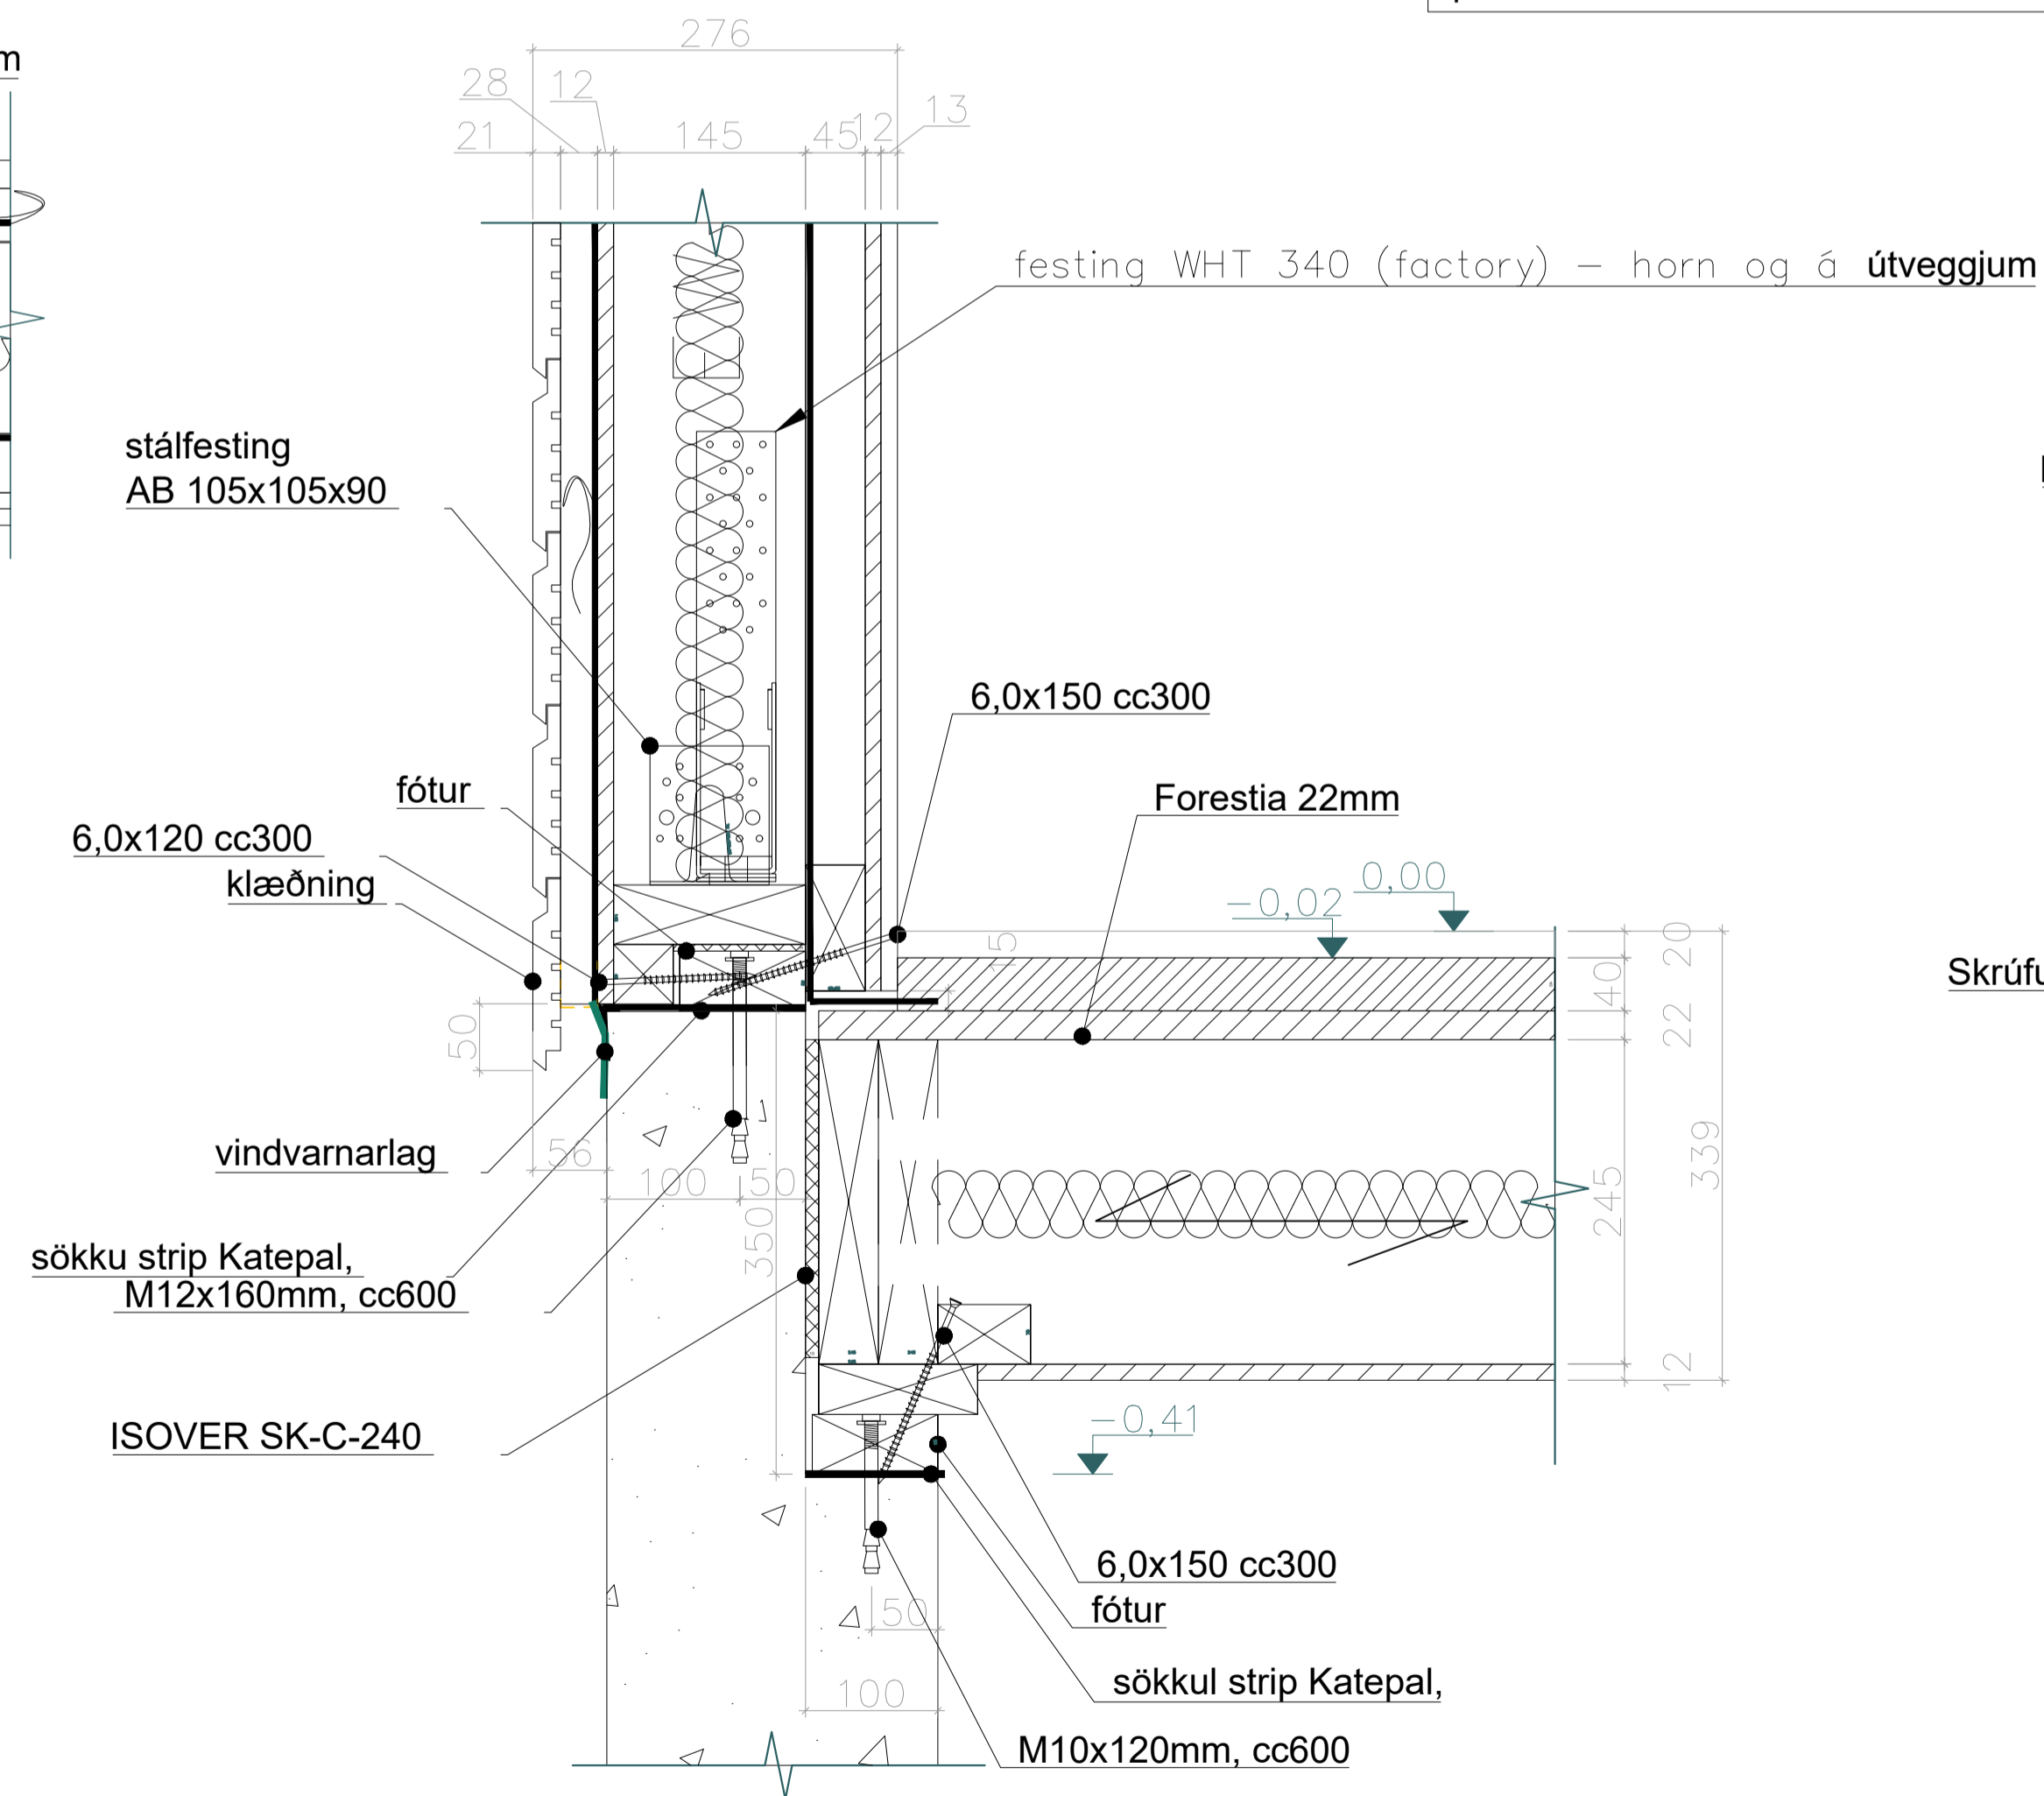
útveggur sökkull

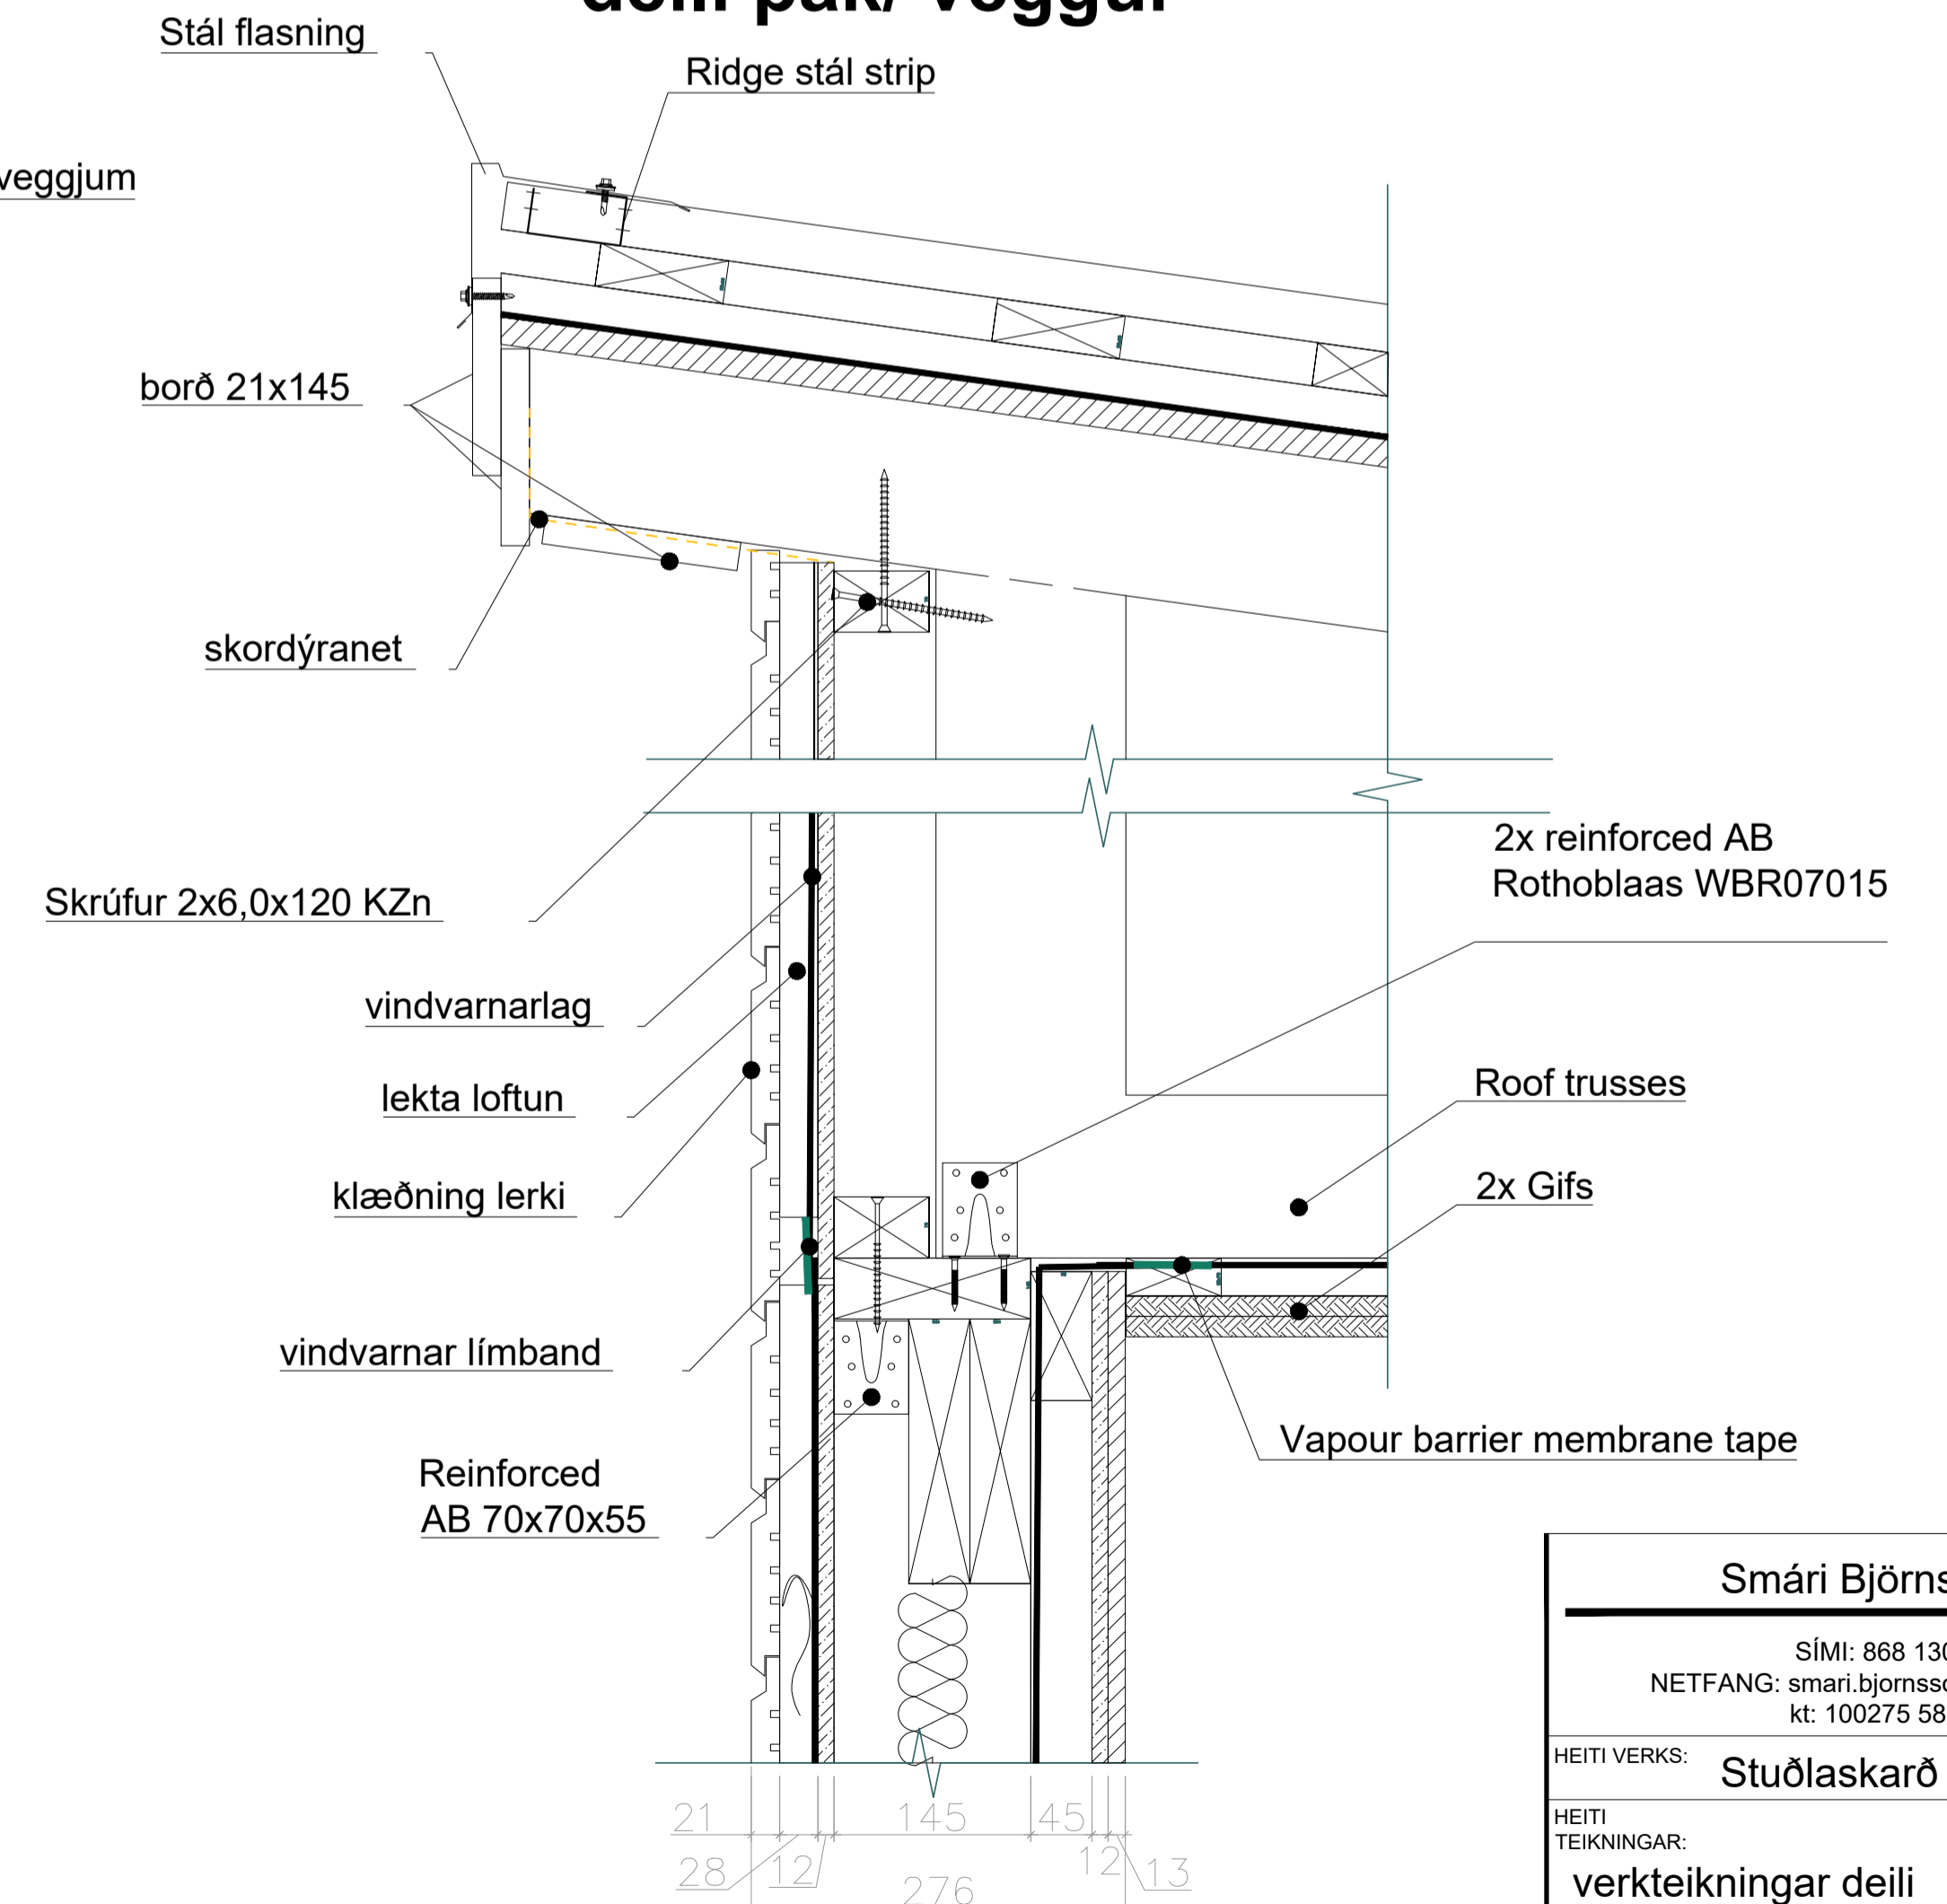
deili pak/ veggur

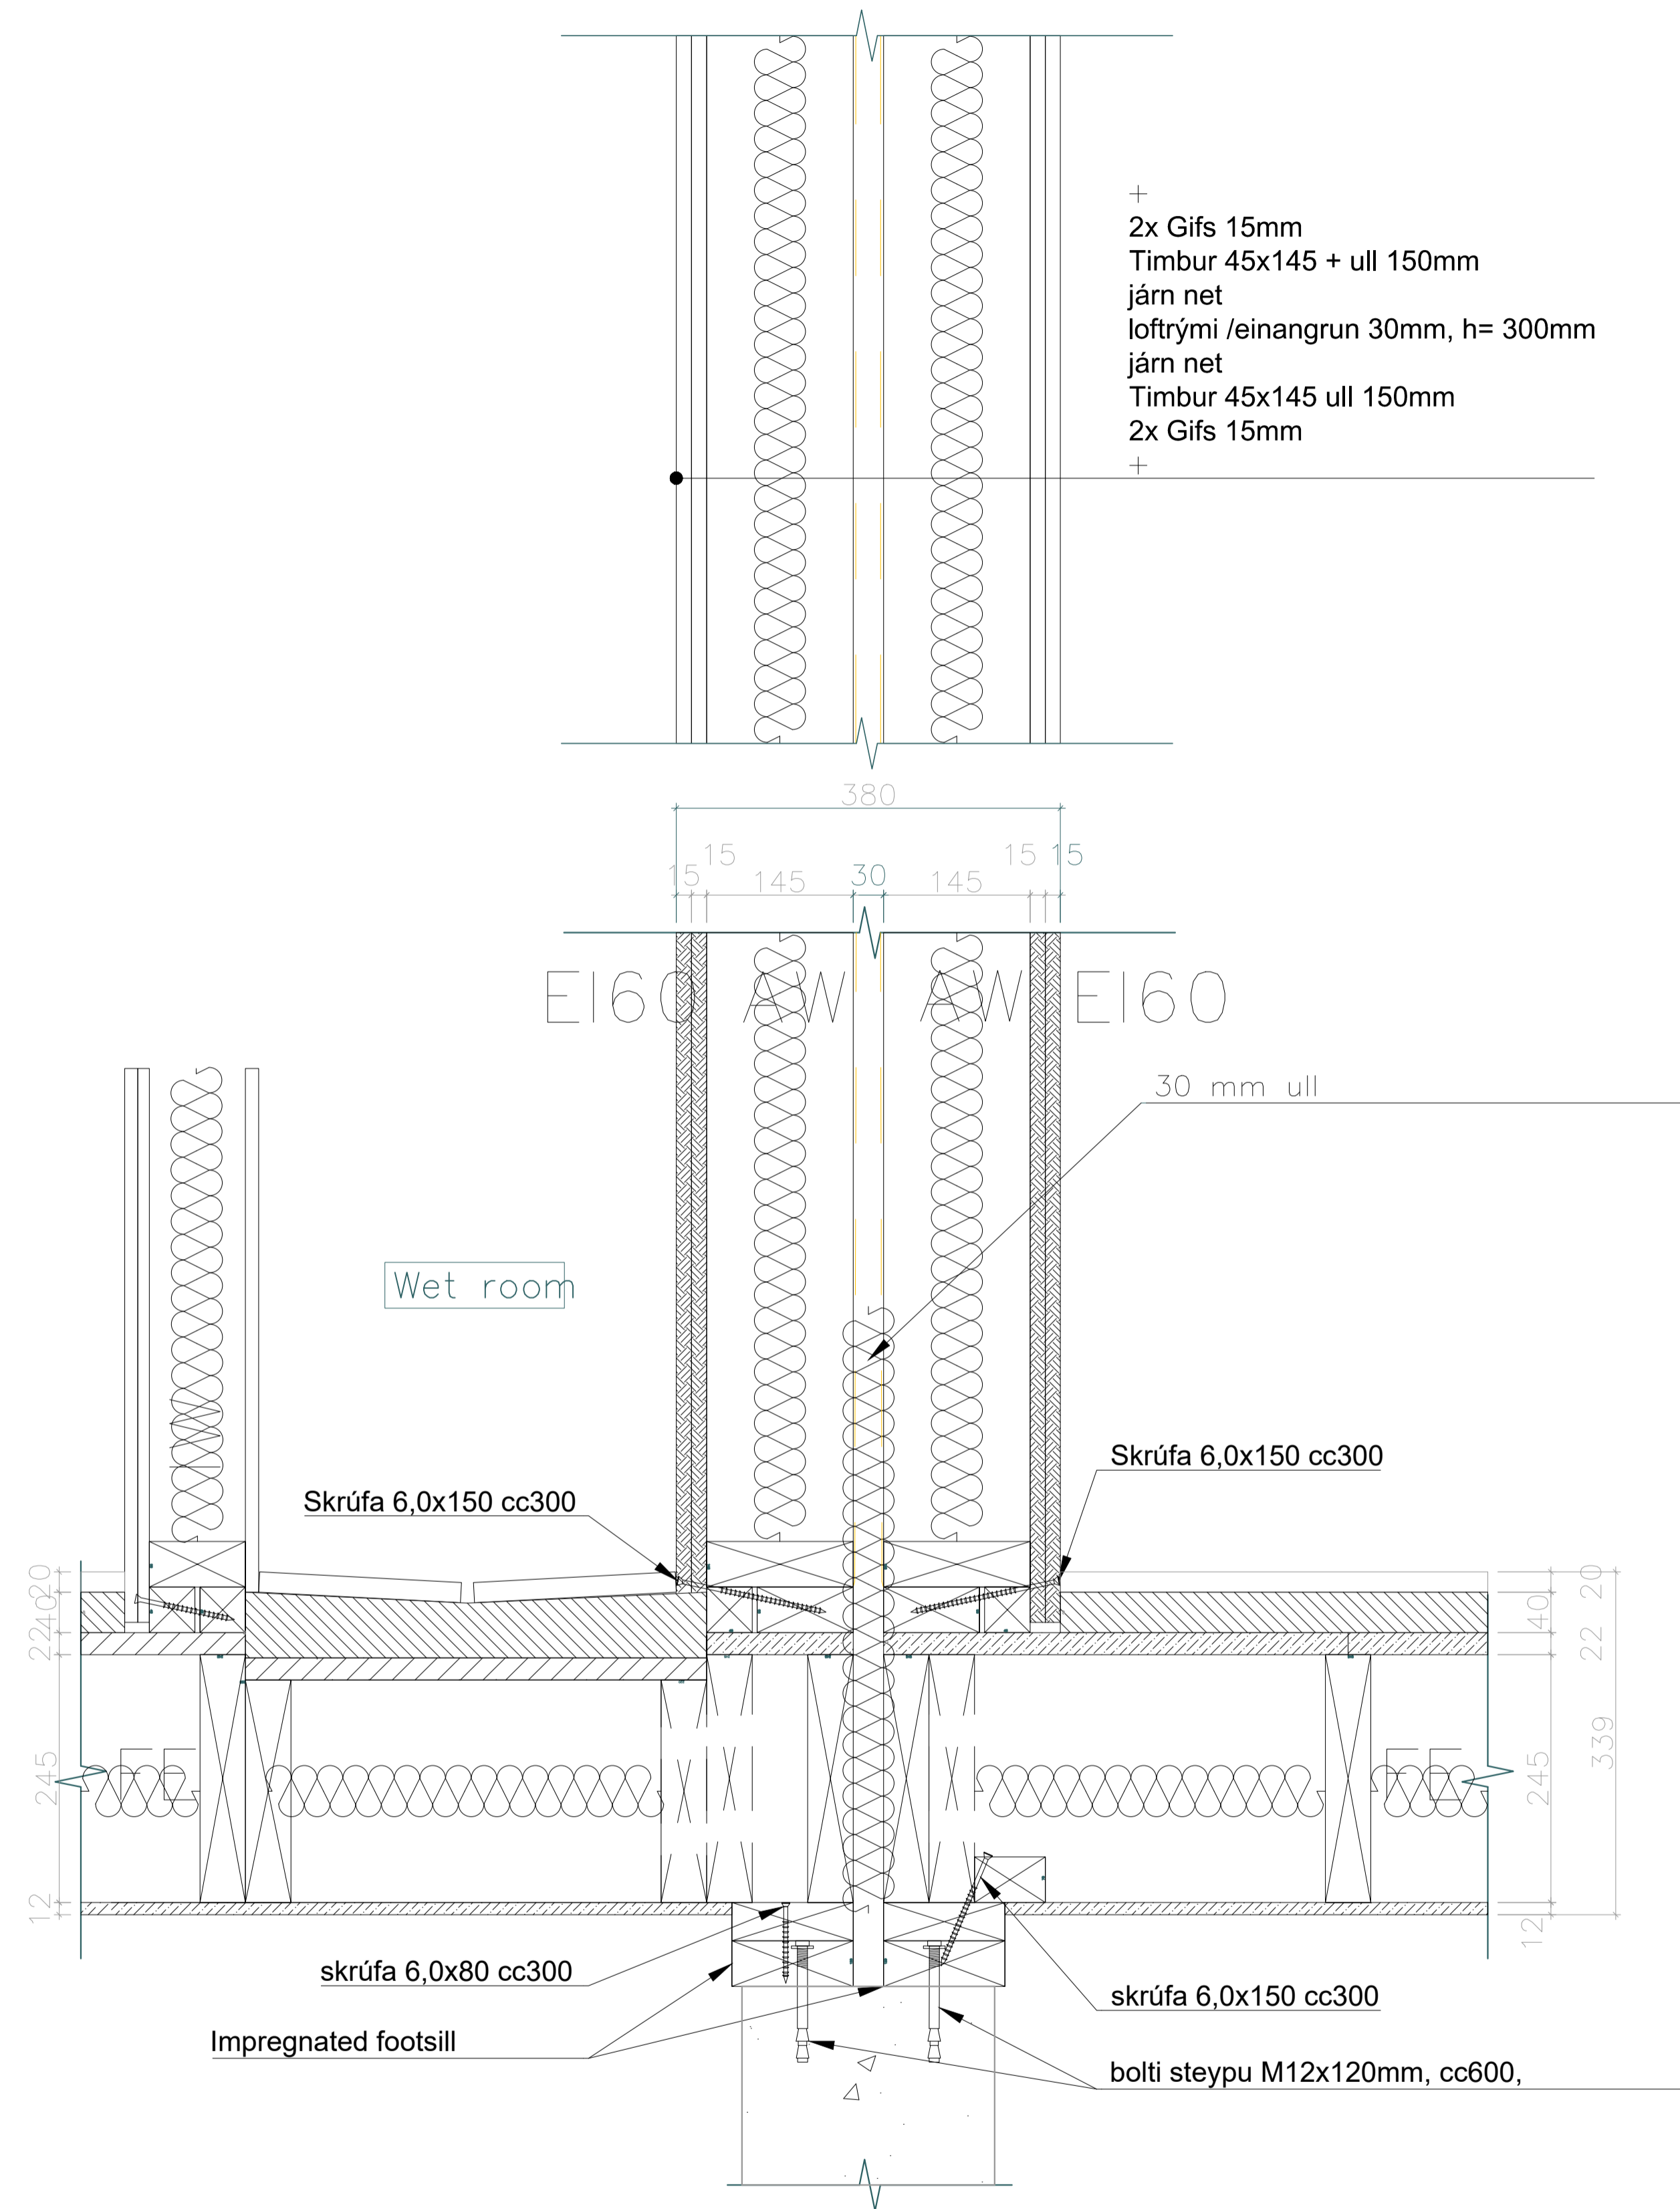
deili veggur milli íbúða
